Overcoming the Crisis in Mosaic Conservation

By Thomas Roby
Getty Conservation Institute

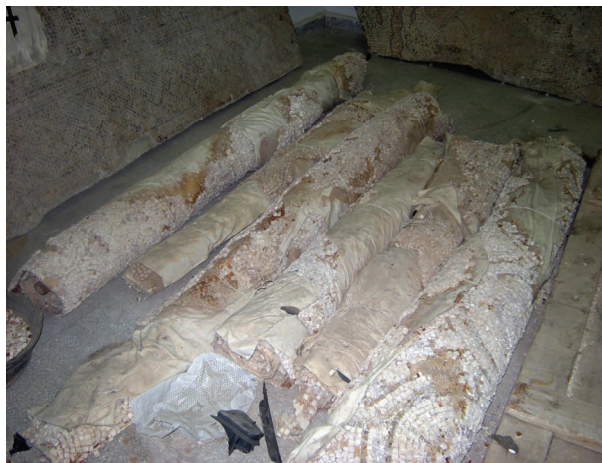
Figure 1. Detached mosaics in temporary storage, Dara, Syria.

As a result, there is a crisis situation in mosaic conservation in some countries including a substantial backlog of detached mosaics in stock piles waiting to be backed so that the facing and adhesive can be removed before they deteriorate and the mosaic is lost tessera by tessera (Figures 1 & 2). There is also a crisis concerning mosaics that have been detached and re-laid on reinforced concrete panels and either replaced *in situ*, put in storage, or displayed on museum walls. Reinforced concrete was commonly used for backing of mosaics throughout the 1960s and 1970s in many Mediterranean countries, and after forty years or less, this type of backing, particularly if left exposed on sites, begins to break apart due to the corroding and expanding rebar (Figures 3 & 4). National authorities now face very difficult decisions concerning the hundreds of mosaics in this condition. A short-term solu-

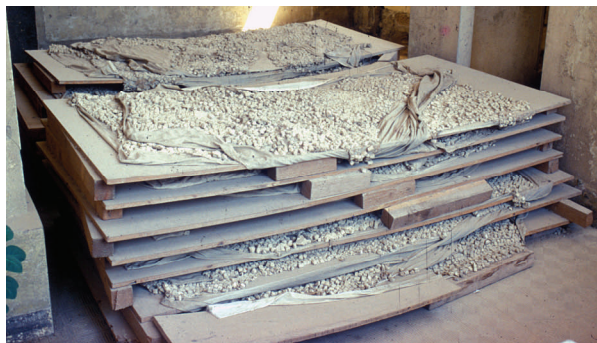
Figure 2. Detached mosaics in temporary storage, Beirut, Lebanon.

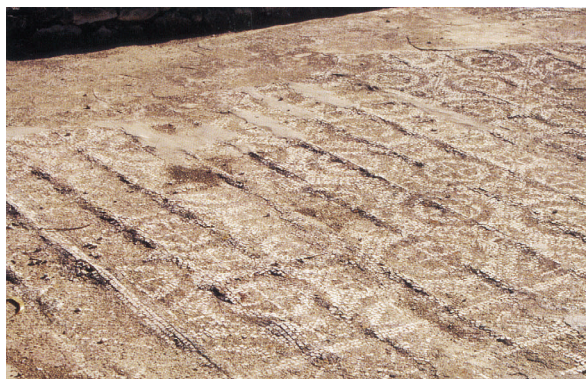
Figure 3. Corroding and expanding rebar disrupting surface of relaid mosaic on reinforced concrete, El Djem, Tunisia.

tion can be to remove and replace the corroding rebar that is causing the loss of tesserae; but the long-term solution is protection by a shelter to prevent exposure to rainwater, or the removal of the entire backing and replacing it with another more compatible, reversible and stable backing system. For those mosaics relaid *in situ* this could be a lime mortar bedding and foundations similar to the original mosaic foundations. For those mosaics backed with reinforced cement and either left in storage or on display in a museum, lightweight, stable materials would be more appropriate. However, there is already a large backlog of mosaics with reinforced cement backings which require their backing being replaced. Because of a lack of resources and trained personnel, the national authorities by themselves are not able to address this crisis situation either.

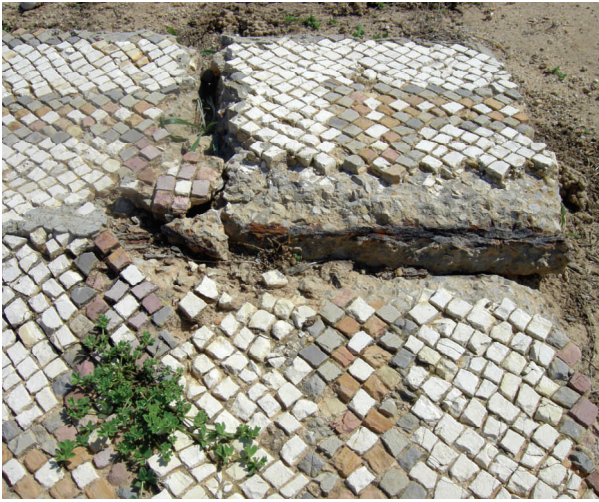
Figure 4. Detail of corroded rebar that has fractured reinforced concrete panel, Hergla, Tunisia.

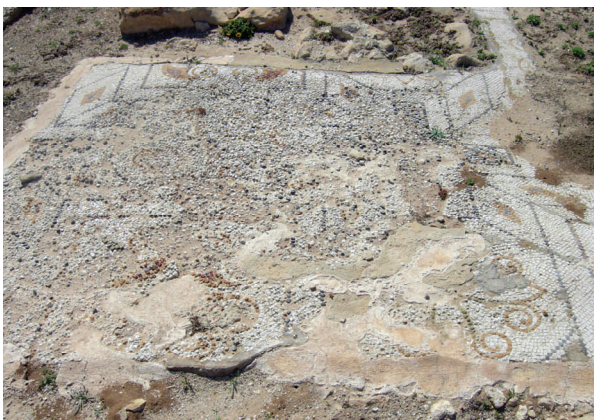
Figure 5. Exposed *in situ* mosaic in advanced state of deterioration due to lack of protection and maintenance, Hergla, Tunisia.

Those mosaics on sites that escaped being detached and relaid in past decades have also reached a crisis situation in many countries, if there is anything left of them (Figure 5). Excavations carried out by foreign archaeologists up to a century ago, and now more often by local archaeologists, have left a vast number of mosaics exposed on sites which are beyond the resources and skills of the authorities to protect and maintain. The options faced by the authorities regarding the conservation of mosaics still on their original bedding are much better than if they had been detached and relaid. An *in situ* mosaic on its original bedding can be protected and conserved for the long-term by reburial, while a mosaic relaid on reinforced cement cannot. The other option for *in situ* mosaics is to protect and present them under a new shelter construction (see Gionata Rizzi, "[Sheltering the mosaics](#)

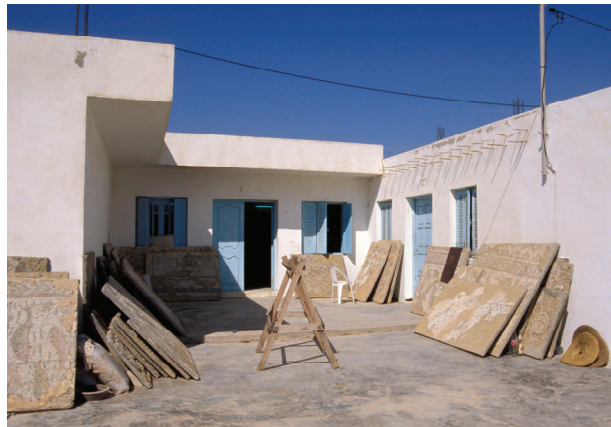
Figure 6. Mosaics relaid on reinforced concrete in temporary storage, Hergla, Tunisia.

The challenge national authorities face in addressing the conservation of mosaics, both those already detached (Figure 6) and those left *in situ* (Figure 7), is daunting, and requires human and financial resources beyond what governments are currently willing to provide. The political will is required to reform and fund their cultural institutions so that they are capable of fulfilling their conservation obligations. The problems they currently face in preserving the ancient mosaic heritage are inherited from decades of poor planning and decision-making, insufficient resources, untrained or poorly trained personnel at all levels, and neglect. While some foreign archaeologists and conservators have contributed to these problems, this kind of needed change is difficult for foreign individuals to effect while working in another country, except by example of their own professional conduct. However, foreign or international institutions, working in a coordinated way and carrying out long-term training initiatives and model conservation projects, can provide the seeds for improved site and mosaic conservation practice and management in the future.

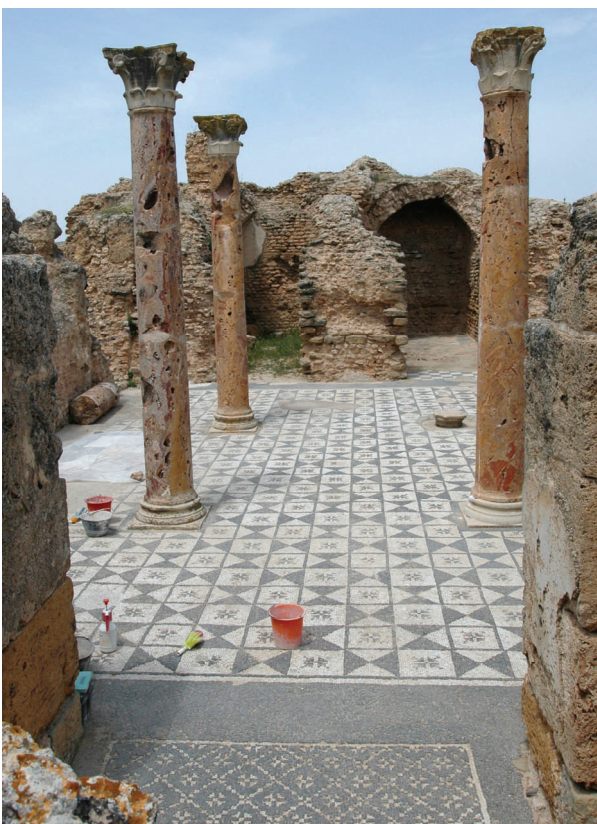
Figure 7. *In situ* mosaic maintained and presented in the open air, Thuburbo Majus, Tunisia.

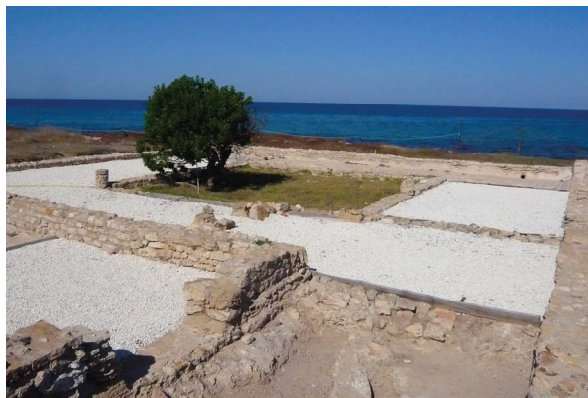
Figure 8. Reburial of mosaics using sand and covering layer of gravel, Hergla, Tunisia.

New discoveries of mosaics will continue to present opportunities and burdens for archaeologists and national conservation authorities, but with national policies of limiting the detachment of mosaics and strategies for the reburial of *in situ* mosaics preceded by their documentation and stabilization (Figure 8), the current crisis in mosaic conservation in many countries could be overcome. It is a cliché in the conservation field that the biggest conservation problems faced today are those created by the interventions of the past, but it is especially true in the mosaic conservation field where the many mosaics which have been detached and relaid on reinforced concrete in the past have created perhaps the most serious problem for the contemporary conservator. Conservation and technician training initiatives in Mediterranean countries should focus not only on *in situ* conservation, but also on techniques for removing harmful backings and relaying them, as much as possible, back *in situ* on lime mortar foundations. In this way, the long-term protection of the relaid mosaic can also be addressed most economically through reburial. As a preventive conservation intervention, reburial is well-suited to protecting archaeological mosaics as they decorate mainly horizontal floor surfaces. Yet in many coun-
